# Experimental Investigations on the Effect of Liner Surface Properties on Wear in Non-Firing Engine Simulator

Article in SAE Technical Papers · March 2004

Dhananjay Kumar Srivastava<sup>Y</sup>, Avinash Kumar Agarwal<sup>X</sup>

Indian Institute of Technology Kanpur

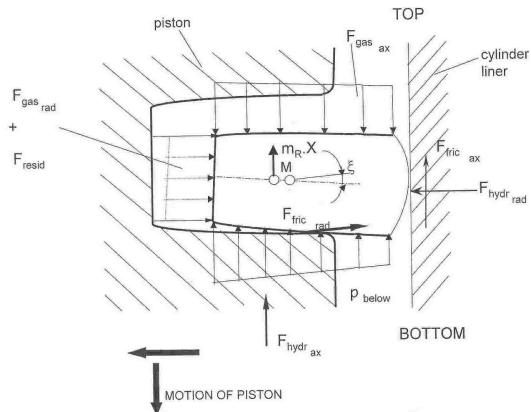
Figure 1: Forces Acting Upon a Ring

There are a host of forces applied on a piston ring in an engine. These forces include several axial and radial forces. Axial forces acting on a ring include Mass force, Frictional force acting between liner and ring, Axial gas force, Hydrodynamic damping force due to oil filling of the groove, bending force due to thrust side and anti-thrust side etc. Radial forces include force due to residual stresses in the ring, gas forces acting on the rear side of the ring, frictional force between ring and ring groove, forces due to hydrodynamic pressure including radial damping force etc. All of these forces are shown in a schematic diagram in figure 1.

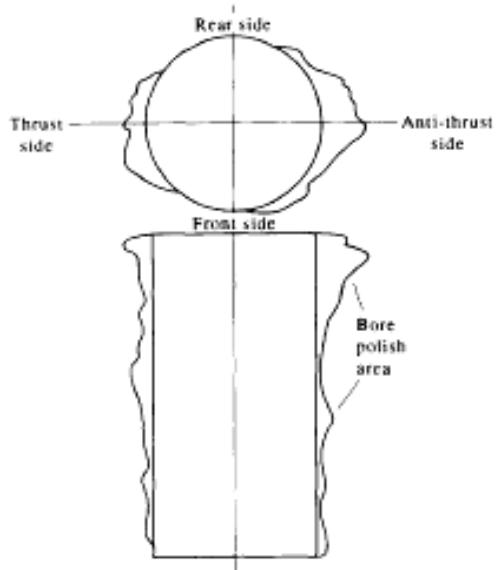
Figure 2: Exaggerated Diagram of Typical Cylinder Liner Wear [9]

The wear of liner is different at thrust side and anti thrust side and also it is different over the stroke length. This can be seen in an exaggerated view of liner shown in figure 2. Higher wear takes place at TDC in a cylinder liner and there is measurable wear all over the stroke length [7,8]. As can be seen from figure 2, higher wear takes place on the anti-thrust side compared to the thrust side [9].

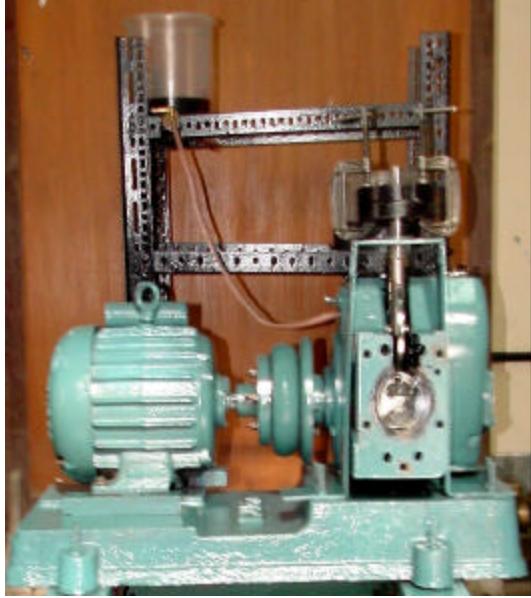
Figure 3: Reciprocating Wear Simulator

A reciprocating wear simulator was designed and developed at IIT Kanpur. The main objective of developing this simulator is to investigate the effect of various surface properties of liner and ring on the frictional forces and lubricating oil consumption in an engine. A single cylinder engine was converted into a machine, which can simulate exact engine operating conditions except firing pressures. Actual production grade piston, rings and liner can be used in this simulator in order to approximate the engine conditions to a much closer extent compared to reciprocating wear tester. The advantage of this simulator was also that it was exposed to full stroke length rather than a short stroke as in the case of reciprocating wear tester. Figure 3 represents the reciprocating wear simulator.

The simulator was driven by 1 horsepower electric motor. The piston used in the simulator has five rings (two compression rings, one scrapper ring and two oil rings).

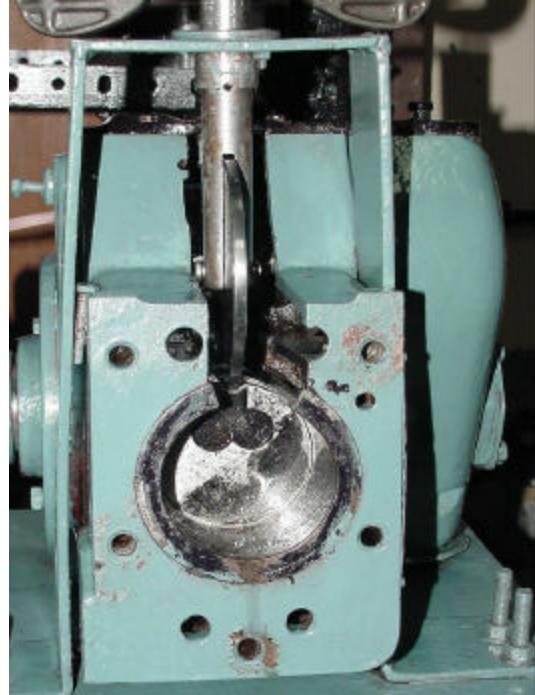
Figure 4: Loading Mechanism on the Piston

The loading on the rings can be changed by a suitable loading arrangement provided in the simulator as shown in figure 4. Currently, testing can be done at room temperature at variable load. However provision can be made for heating the liner to the temperatures close to actual firing engine. The simulator is lubricated at several locations using gear-pump based lubrication system. The oil used for this purpose is SAE 20 W 40. The stroke length

Since, this reciprocating machine is a non-firing machine hence additional loading to compensate for gas forces is done using a special loading mechanism to provide additional load in radial direction. Load is given on the piston, as shown in figure 4. The liner diameter is 82 mm. The liners need to be cut in order to make provisions for loading of the rings. Hence a 40 mm wide cut is made on the liner along its length so that load can be transferred directly on the piston and in turn on to the rings. A suitable groove is also machined on the piston and a wheel is provided so that the load can be transferred even when the piston is reciprocating. The liner used in the simulator is shown in figure 5. Provisions are made to stop the circumferential movement of the rings in the piston grooves by providing pins in suitable locations.

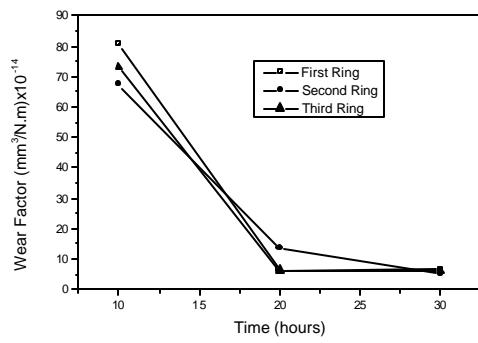
Figure 6: Wear Factors for the Top Three Rings

The data was analysed and plotted for the top three rings in figure 6.

Wear rates for initial 10 hours decreases for all rings as shown in figure 6. After 20 hours, the wear rates become fairly stable and subsequently, the material removal rate from the rings reduces and remains fairly constant.

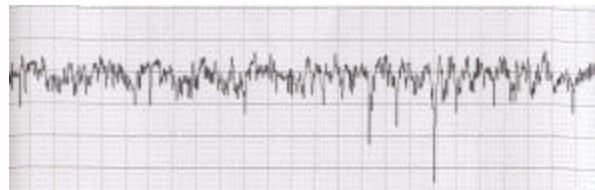
Figure 7: Profile of Fresh Honed Liner  
(Vertical Scale: 10.0  $\mu\text{m}/\text{cm}$ )

The surface profile of the liner surface was done using Mitutoyo make surface roughness tester, model SJ-301. The profile of the liner was done before starting the test as shown in figure 7 and then the profiling was done after the conclusion of the test at three locations as shown in figure 8-10. The roughness data of the profile is given in table 2.

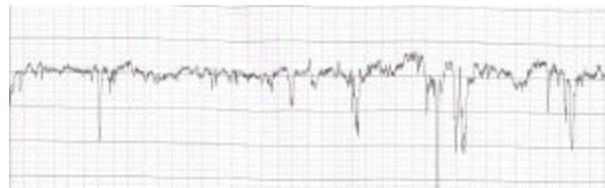
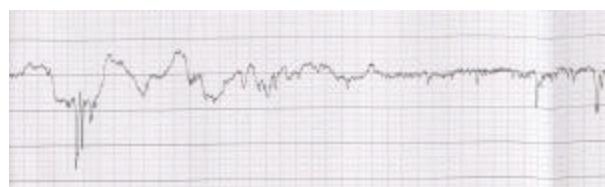
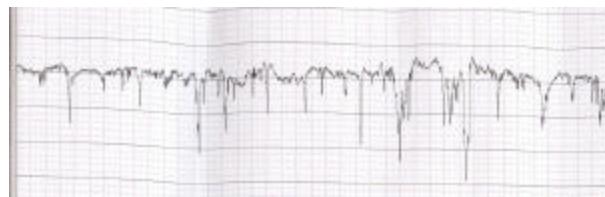
Figure 8: Profile of Liner after Experiment (TDC)  
(Vertical Scale: 2.0  $\mu\text{m}/\text{cm}$ )

Figure 9: Profile of Liner after Experiment (Mid Stroke)  
(Vertical Scale: 5.0  $\mu\text{m}/\text{cm}$ )

Figure 10: Profile of Liner after Experiment (BDC)  
(Vertical Scale: 2.0  $\mu\text{m}/\text{cm}$ )

The profiles of the liner clearly show that there was higher amount of wear at the TDC location and finer plateau-honing takes place after 30 hours of operation in reciprocating mode. After running in an engine, surface profile of liner also shows similar plateau-honed liner. This surface is relatively stable in terms of wear. Therefore, building plateau-honed liner can control initial wear of an engine and thus reduce the amount of wear debris generation during the initial running-in period. The results of the profile are also supported by the roughness parameters shown in table 2 below. It is clearly evident from the data that the wear is higher at TDC location and is lower in mid-stroke position. BDC position shows higher wear than the mid-stroke position. This is because at the extreme positions of TDC and BDC, the linear velocity of the piston is close to zero and its maximum at mid-stroke

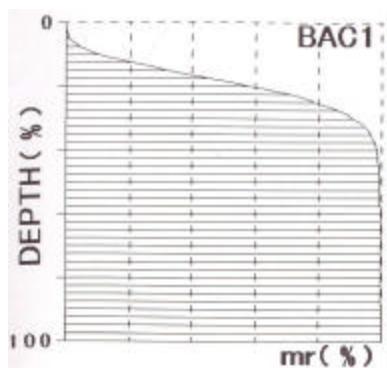
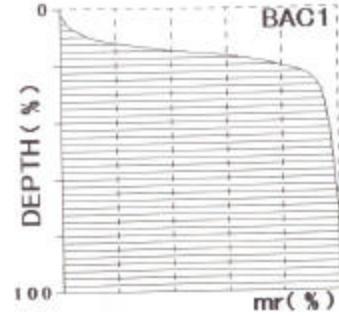
Figure 11: Bearing Area Curve of Honed Liner

Figure 12: Bearing Area Curve of Liner after Experiment (TDC)

The  $R_k$  family of parameters was used to characterize the liner surface. These parameters were selected over more conventional parameters because they take into account not only the height of surface features, but also their width. The  $R_k$  parameters are derived from bearing area curve of the surface. Figure 11 and figure 12 shows bearing area curve of liner, before and after the experiment.

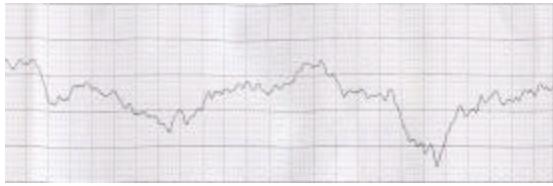
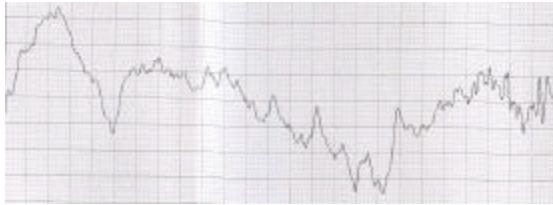
Figure 13: Surface Profile of Top Ring before Experiment  
(Vertical Scale:  $20 \mu\text{m}/\text{cm}$ )

Figure 14: Surface Profile of Top Ring after Experiment  
(Vertical Scale:  $0.5 \mu\text{m}/\text{cm}$ )

The profile of the top ring was done before and after experiment as shown in figure 13 and figure 14. Roughness parameters of ring profile are given in table 4.

The parameters indicate the extent of wear on the top ring during the experiment while using honed liner.

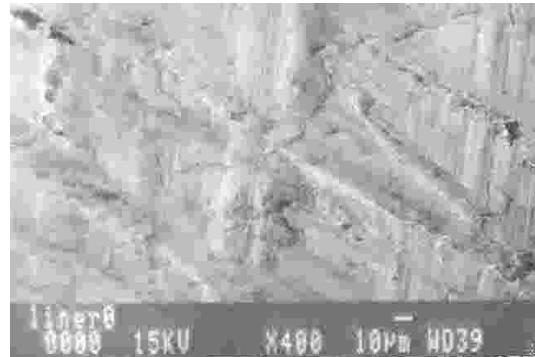
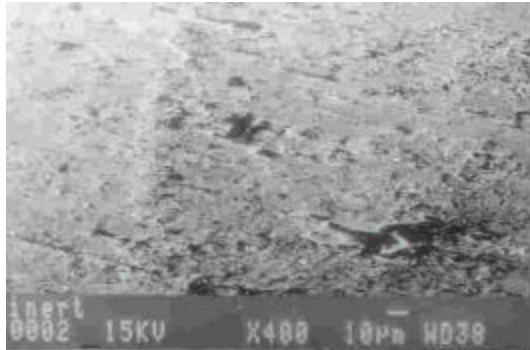
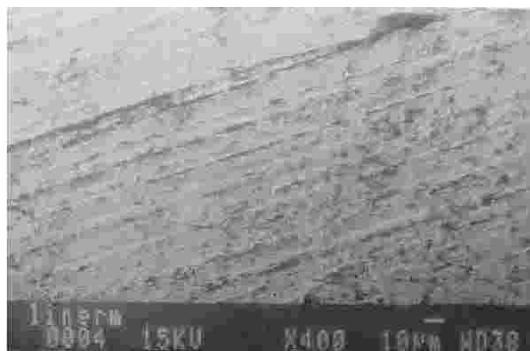
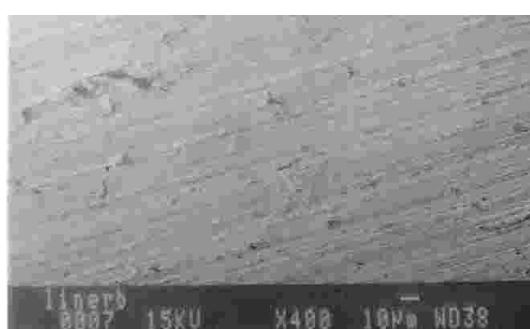
The SEM for liner was done before starting the test as shown in figure 15. The magnification used is 400X. The SEM was also conducted for the liner segments after completing the test at the three locations similar to profile. Figure 15 shows a scanning electron microscope (SEM) photograph of the fresh honed liner. One can see the typical crosshatched honed structure in the honed liner. Figure 16-18 show SEM micrographs of liner at TDC, mid position and BDC respectively. It is clearly visible that higher wear takes place at TDC location compared to mid position and BDC location. The crosshatched honing marks are completely removed from TDC location clearly showing the extent of wear that takes place in 30 hours of simulator operation.

Figure 15: SEM Micrograph of the Liner Surface before Starting the Test

Figure 16: SEM Micrograph of the Liner Surface After 30 Hours at TDC Location

Figure 17: SEM Micrograph of the Liner Surface After 30 Hours at Mid-Stroke Location

Figure 18: SEM Micrograph of the Liner Surface After 30 Hours at BDC Location

The SEM micrographs shown in figure 15-21 clearly show the extent of wear on ring and liner surfaces at different locations and verify the earlier results of wear rates and profile.

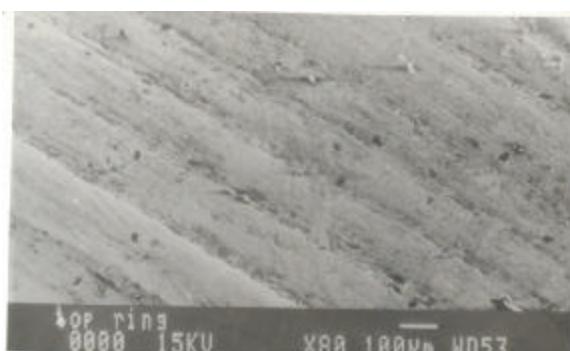
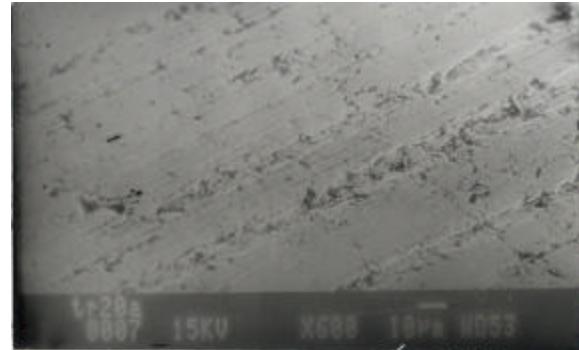
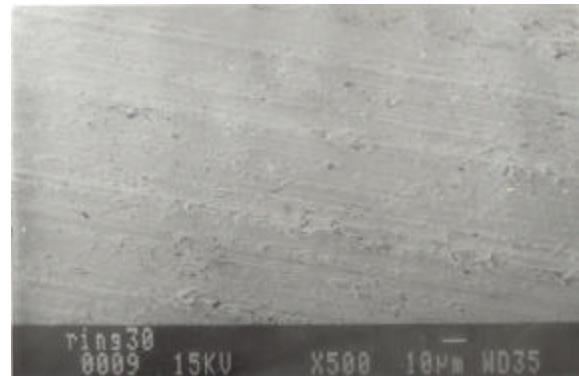
The SEM for the top ring was also conducted before executing the test and the micrograph is shown in figure 19. The SEM of the top ring was also conducted after 20 hours and 30 hours respectively as shown in figure 20-21. These also reflect that there is significant amount of wear that takes place on hard surface of the chrome plated top ring.

Figure 19: SEM of Unused Top ring

Figure 20: SEM of Top Ring after 20 Hours.

Figure 21: SEM of Top ring after 30 hours.
