# Improving cavitation erosion resistance of austenitic stainless steel in liquid sodium by hardfacing – comparison of Ni and Co based deposits

# B.K. Sreedhar<sup>a,\*</sup>, S.K. Albert<sup>b</sup>, A.B. Pandit<sup>c</sup>

<sup>a</sup> Fast Reactor Technology Group (FRTG), Indira Gandhi Centre for Atomic Research (IGCAR), Kalpakkam, India

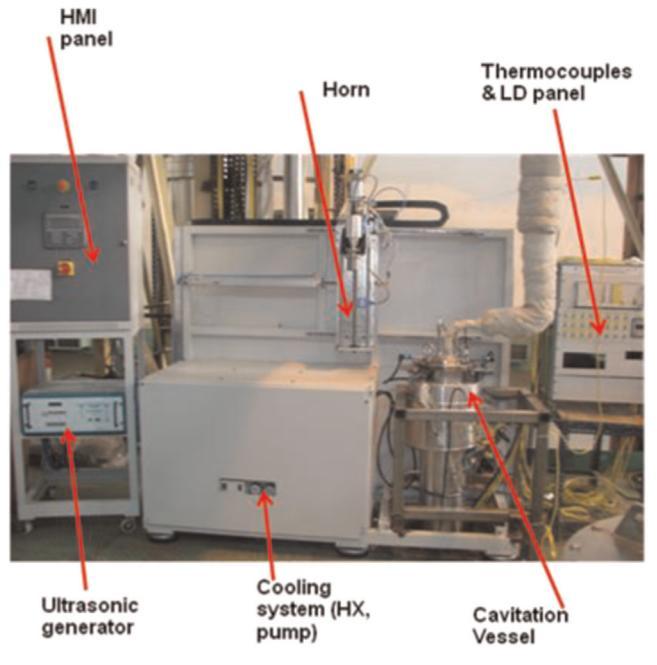
The cavitation erosion test facility (Fig. 1) consists of cavitation vessel, dump tank, vibratory cavitation equipment and cover gas system. The vibratory cavitation equipment (Roop Telsonic Ultrasonix, series SG 22) employs a piezoelectric transducer to generate the high frequency vibratory motion. The facility is designed to be in conformance with ASTM G 32 which outlines the requirements to be met (such as dimensions of vessel, immersion depth, dimensions of specimen, equipment operating parameters and their control) for cavitation erosion testing using the vibratory method. The facility and the detailed test procedure are described elsewhere [29].

Fig. 1. Cavitation erosion test facility.

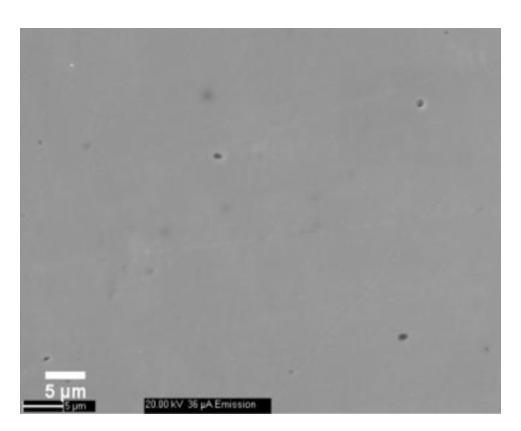
Fig. 3. SS 316L (surface finish 0.3 µm).

Fig. 3 is the SEM image (taken using Obducat Camscan-3200 SEM) of the polished SS 316L specimen. The specimen is polished to surface finish of 0.3  $\mu$ m and the measured hardness is 95.9 HRB (Table 1). Fig. 4 is the SEM image of Colmonoy5 specimen polished to 2.8  $\mu$ m. The deposit thickness is ~1.5 mm and the measured

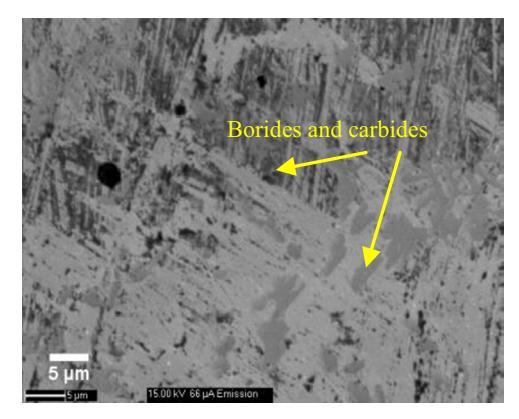
Fig. 4. SEM image – Colmonoy sample (surface finish 2.8  $\mu m)$  in polished condition. The carbides and borides are visible in the better polished bottom region.

maximum hardness is 41.7 HRC. The borides and carbides in the hard facing are visible on the surface without any etching. Fig. 5 shows the Stellite6 specimen with deposit thickness of ~1.5 mm, surface hardness of 39.4 HRC and polished to 0.4  $\mu$ m. In this case also the carbide network present in the hardfaced coating is revealed clearly without any etching.

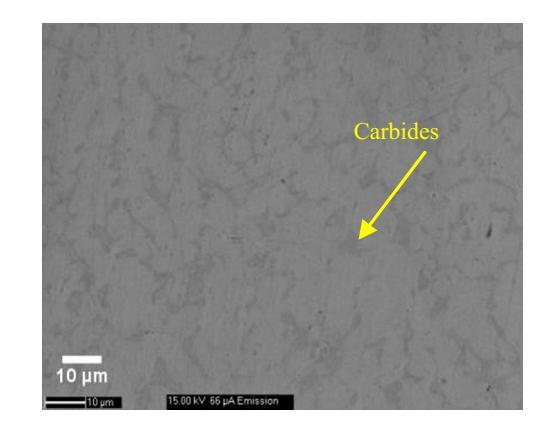
Fig. 5. SEM image – Stellite sample (S2) (surface finish  $0.4\,\mu\text{m})$  in polished condition.

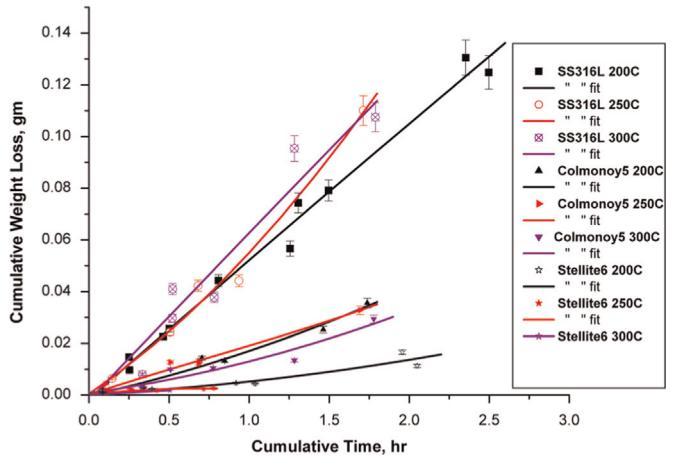
Comparison of weight loss in sodium at different temperatures SS 316L and hardfaced (Colmonoy5, Stellite6) materials

Fig. 6. Effect of hardfacing on weight loss due to cavitation damage.

The variation of the measured cumulative weight loss (gm) with time and the cumulative weight loss rate (gm/h) with time for the above specimens at the various test temperatures are shown in Figs. 6 and 7 respectively. It is evident from both figures that hard facing results in marked improvement in the cavitation damage resistance of SS 316L. It is also apparent that Stellite6 is more resistant to cavitation than Colmonoy5. The SEM images of the specimens taken at different instants during the test provide additional evidence in support of this.

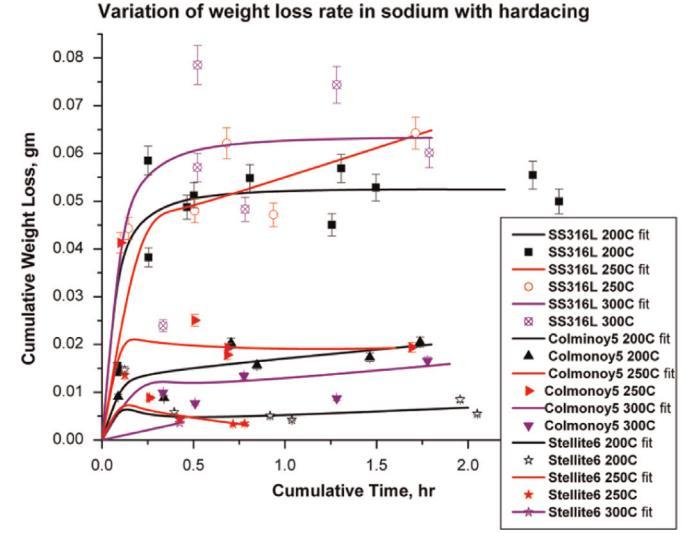
Fig. 7. Effect of hardfacing on weight loss rate due to cavitation damage.

The weight loss rate graph (Fig. 7) also shows that the damage rates for the various specimens have attained steady state (except for SS316L at 250 °C). It is also evident that the steady state weight loss rate exhibits a maximum at an intermediate temperature instead of a monotonic variation with temperature. Although the trend for SS316L looks different, it appears that the steady state weight loss rate at 250 °C will settle at a value higher than that at 200 °C.

The variation with temperature may be explained in terms of liquid properties. Increase in liquid temperature results in increase in the vapor pressure of the liquid and decrease in the equilibrium concentration of dissolved gas. Increased vapor pressure results in (i) increase in the bubble population/increase in bubble size at the end of expansion resulting in increase in damage (ii) increase in back pressure at the end of collapse resulting in decrease in damage. Decrease in equilibrium gas content results in a decrease in back pressure opposing collapse which results in increase in damage. These opposing effects manifests in the damage attaining a peak at an intermediate temperature.

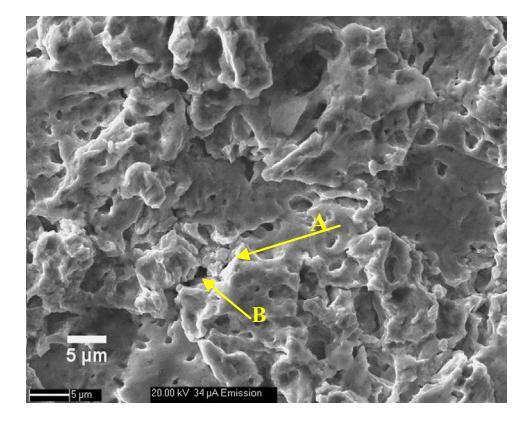
Figs. 8 and 9 are SEM images of SS 316L specimen early on during the testing and after prolonged exposure to cavitation.

It is seen from Fig. 8 (after test interval of 5 min 2 s) that in SS 316L the accumulation of slip bands results in initiation of micro cracks (A). Plastic deformation then results in enlargement of the micro cracks and void formation. The adjacent voids coalesce leading to material removal (B). The resulting surface has the

Fig. 8. SEM sample of SS 316L – after cavitation in sodium (period=5 min 2 s, Temp=200  $^{\circ}$ C).

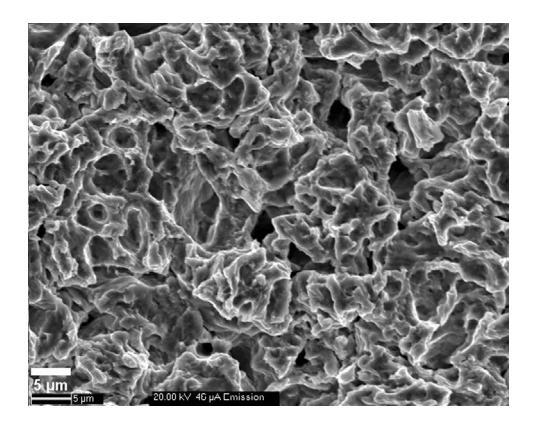
Fig. 9. SEM sample of SS 316L – after cavitation in sodium (period=141 min, Temp=200  $^{\circ}$ C).

dimpled topography characteristic of damage in ductile materials. Fig. 9 shows the damage after prolonged exposure. It is seen that at this stage there is also material removal from the work hardened surface to produce gross pitting of the surface

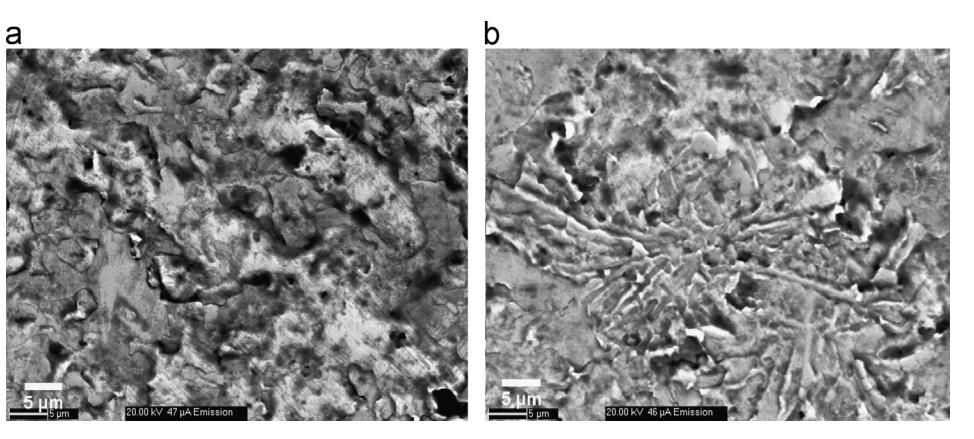
Figs. 10 and 11 show the SEM images of Colmonoy5 hardfaced sample during the test period. Fig. 10(a and b) are the SEM images at an early stage of weight loss after  $\sim 6$  min of testing. It may be seen that damage is initiated at the interface between the hard second phase (borides or carbides) and the matrix. Fig. 10 (b) shows the damage at the interlamellar spacing of the eutectic mixture of matrix and hard second phase. It is observed that extended exposure to cavitation causes the removal of the hard second phase particles from the matrix and the formation of pits as shown in Fig. 11. Also evident is severe deformation of the base matrix. The severity of damage, however, is not as large as it is for SS 316L.

**Fig. 10.** (a)-Colmonoy sample (C3) – after cavitation in sodium (period = 6 min 6 s, Temp=250 °C). Dendrite phases and initiation of material removal at interdendritic regions. (b)-Colmonoy sample (C3) – after cavitation in sodium (period=6 min 6 s, Temp=250 °C). Flower like dendrite phases; material removal begins at hard interdendritic regions.

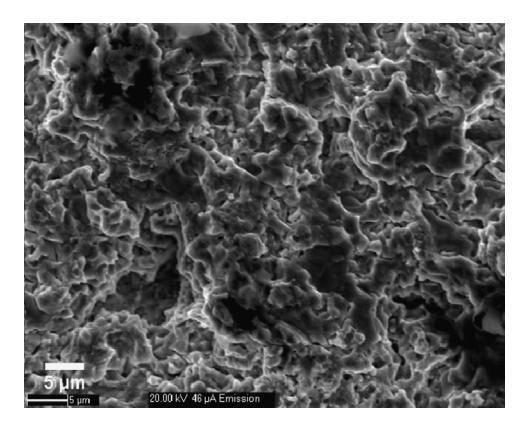
**Fig. 11.** Colmonoy sample (C3) – after cavitation in sodium (period=41 min, Temp=250 °C). The voids are regions where the borides and carbides and portions of the base matrix are removed.

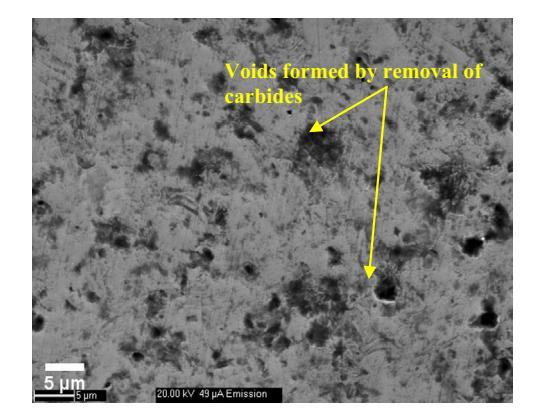
Figs. 12 and 13 are SEM images of the stellited specimen in the course of testing. The SEM image (Fig. 12) during the early stage,  $\sim$ 7 min of exposure, shows that damage is initiated at the interface between the matrix and hard carbide locations. On continued exposure to cavitation, the carbide particles are dislodged resulting in voids at these locations. After prolonged testing, it is observed (Fig. 13) that cracks are initiated in the work hardened matrix resulting in material removal and measurable weight loss.

**Fig. 12.** Stellite sample (S2) – after cavitation in sodium (period= $7 \min 31$  s, Temp= $250 \degree$ C). Cracks at carbide locations resulting in increased stress concentration and removal of carbide particles from these locations.

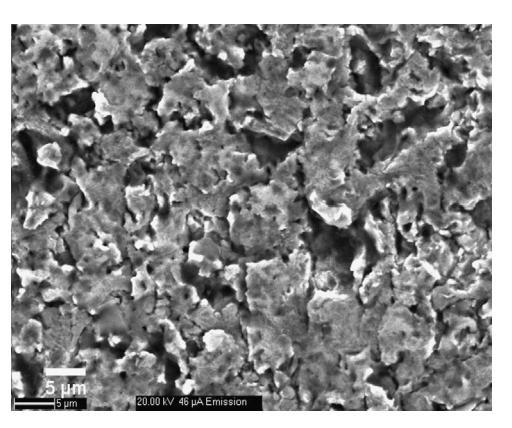
**Fig. 13.** Stellite sample (S2) – after cavitation in sodium (period=42 min, Temp=250  $^{\circ}$ C). Further exposure results in damage propagation to the work hardened matrix.
